MOHAWK RIVER BASIN
BATAVIA KILL WATERSHED PROJECT
DAM No. 3

I.D. No. NY-608
PHASE I INSPECTION REPORT

Name of Dam: Batavia Kill Watershed Project
Dam No. 3 - I.D. No. NY-608 (#191C-3818)

Date of Inspection: July 11, 1978

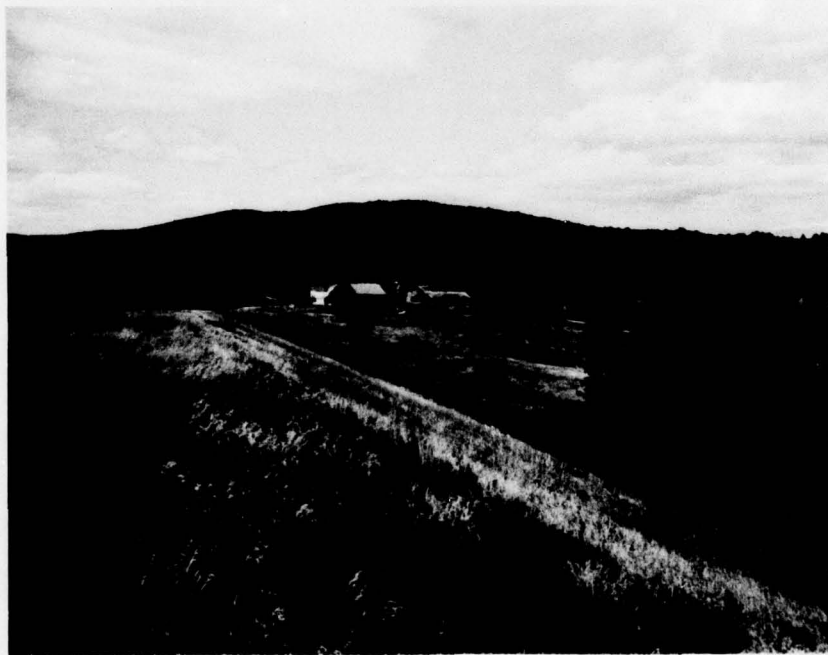
DOWNSTREAM SLOPE
(looking East)

The earth embankment shows no signs of distress. The vertical and horizontal alignment of the crest appears to be unchanged, with no visible surface cracks appearing on the crest or embankment slopes. There was no apparent sloughing, subsidence, or depressions occurring either. No noticeable seepage on the downstream slope was observed. However, discharges estimated at less than 5 gpm per outlet were observed flowing from the internal drainage system indicating that the system is functioning satisfactorily. The upstream slope did not have any visible riprap placed at or near the level of the principal spillway crest elevation. No undesirable vegetative growth or animal penetrations into the slopes were observed. However, the heavy grass cover on the slopes was high, making visual inspection difficult.

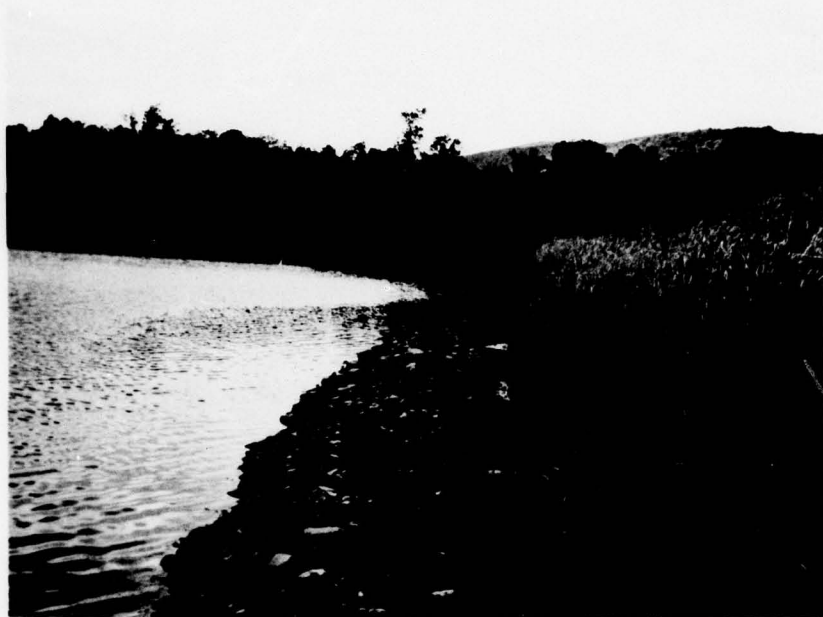
RESERVOIR POOL @ PRINCIPAL SPILLWAY
(looking East)

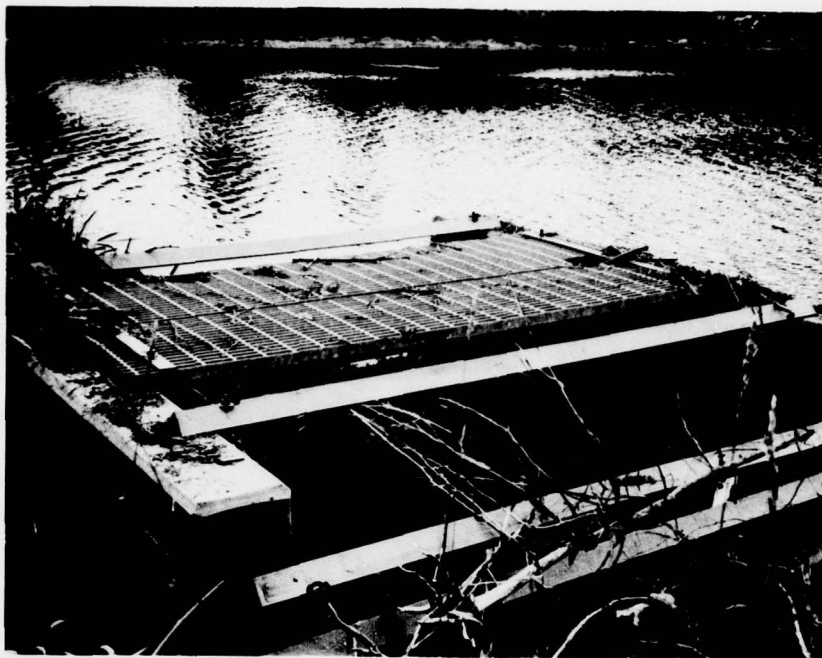
The principal spillway consists of the vertical drop inlet structure, a concrete pressure pipe through the embankment, an impact basin, and an outlet channel. All of these components were in satisfactory condition.

INLET of PRINCIPAL SPILLWAY
@ RISER

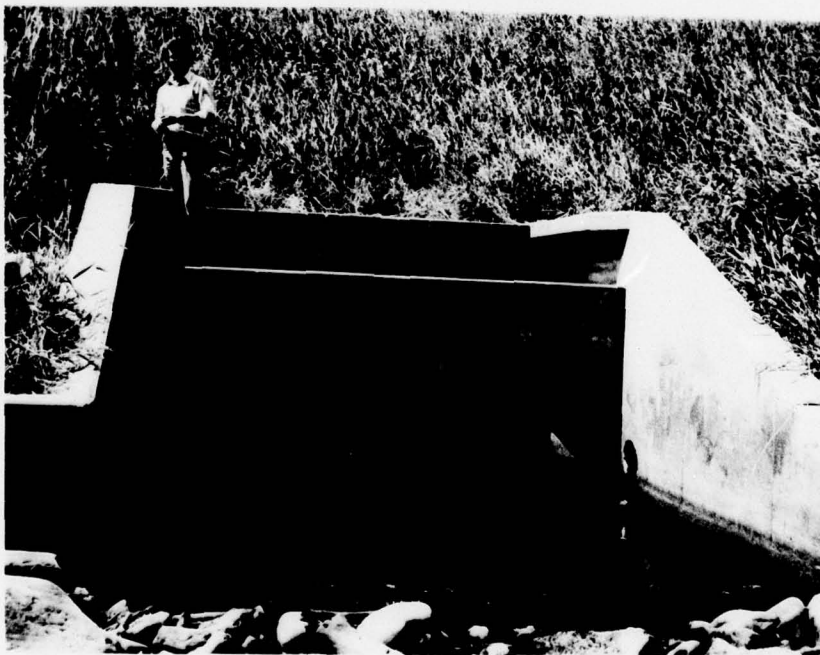
OUTLET of PRINCIPAL SPILLWAY
@ IMPACT BASIN
